# THE THERMOGRAPHIC ANALYSIS OF THE WELDING BY TIG

Centre for Microelectronics and Nanotechnology, University of Rzeszow, Poland

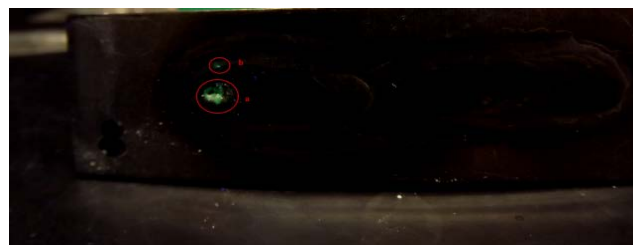
Fig. 1 Sample No. 8 made by Inconel 718 alloy.

In Fig. 1 is shown the results obtained for the penetration method of the sample 8, where two shining areas are observed marked as "a" and "b". In the place marked as "a" shining is lighter what means a deeper discontinuity, with the greater amount of penetrant than the place marked as "b", where shining has a point character.

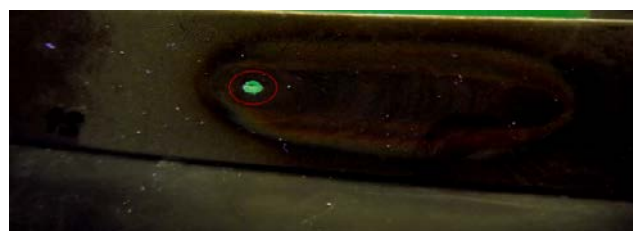
Fig.2 Sample No. 19 made by stainless steel 321

In Fig.2 is shown the sample with a crater at the end of the pad welding on the left side. The purple color on the surface is coming from a pollution.

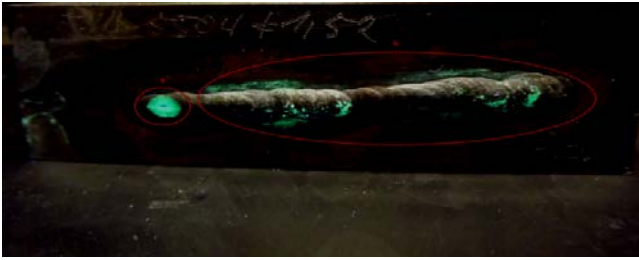
**Fig.3** Sample No. 23 made by stainless steel 410

On the surface of the pad welding of the sample 23, shown in Fig.3, the crater is observed also on the left side of sample, which is evidenced by the green-yellow shining of the round shape (area "a"). Others shining places have an irregular shape. They are originated by an inequality and by the roughness of the surface.

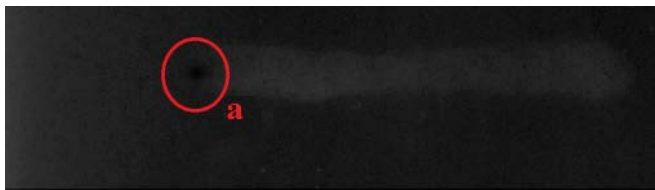
**Fig. 4** Radiogram of weld sample No. 8

- in the sample 8 the area "a" indicates that in the place of crater observed by the penetration method (Fig.1) the crack occurs inside the sample;
- the same situation takes place with the sample.
- in the sample 23 are observed not only the cracks inside the sample but a gas bladder exists inside the weld.

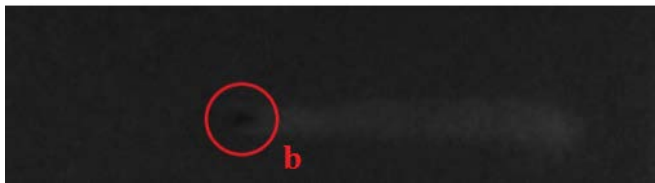
**Figs.5.** Radiogram of weld sample No. 19

Radiographic examination confirms the presence of surface defects detected by the fluorescent method but radiographs revealed the presence of internal defects in the sample 23 (Fig.6) where was observed air bladder. Besides that, the Figs. 5 and 5 registered place of incomplete joint penetration at the ends of joints: the cracks inside the craters, which are not recorded using fluorescent method.

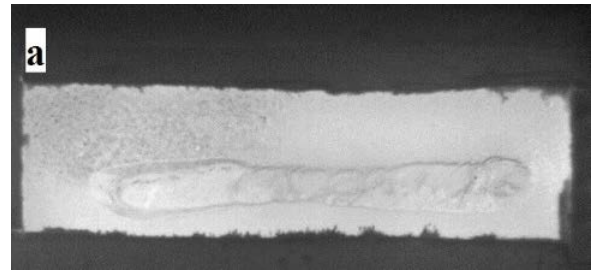
In Figs. 7, 8 and 9 are shown the thermograms for the same samples 8, 19 and 23 with welds. Fig.7a show the IR picture obtained for the sample 8 during the heat pulse of the 30 ms time. From the 7a thermographic image, obtained directly by IR camera it couldn't be possible to identify the region of the defects. It is only possible to observe the surface roughness of the weld.

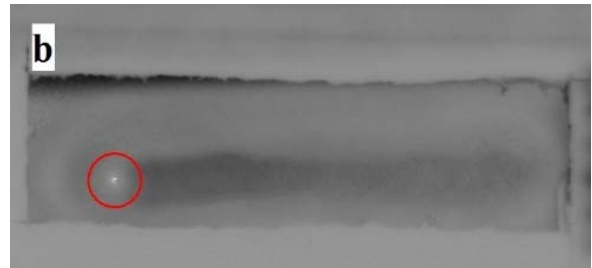
However, the thermogram 7b, obtained after treatment by the IrNDT computer program, enables to find the bright spot (in the area marked with a red circle). Comparing with the radiological and penetration results confirms that this is the crater observed in Figs. 1 and the crack visible in Fig. 4.

The thermography method enables also to reveal the defects inside the welds. In the region of the defect where crater was observed by fluorescent method (Fig. 1) the bright point is detected in Fig. 7b on a darker background of the rest of the pad welding (lower grades of gray-lower temperature) indicating on the inner defect – crack registered by the radiograph (Fig. 4). Also in the thermogram (Fig.9b) is observed the contours of the bladder registered by radiographic method (Fig.6), where the blackout was greater than in the rest of the pad welding. The reason for this is presence of a gas, which acted as an insulator passing also were heat impulse. On the right side of the sample in Fig 9b internal defect is appeared as a light point. The layer thickness at this point was less due to the presence of the crack in the crater. The area was warmed faster than the rest of the weld.

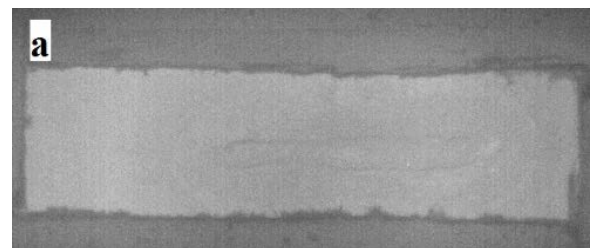
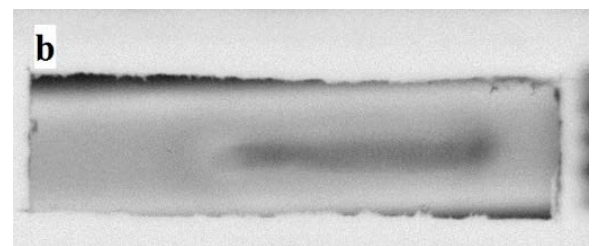
**Fig.8.** Thermograms of weld sample no. 19, a-thermogram directly registered by IR camera, b - thermogram obtained after computer treatment in IrNDT program.

Analogously, in the case of sample 19 shown in Figure 8a, the picture is obtained directly by IR camera, doesn't indicates the defects in the weld. On the thermogram recorded at 50 ms heat pulse and depicted in Fig. 8b the defect observed by penetration (Fig.2) and radiographic (Fig.5) methods, is located at the end of the right side of the weld.

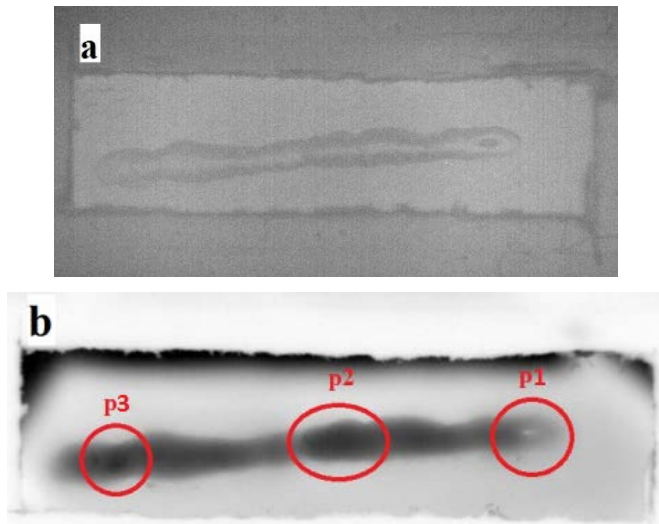
Fig. 9 Thermograms of weld sample no. 23, a-thermogram directly registered by IR camera, b - thermogram obtained after computer treatment in IrNDT program.

Fig. 9 a,b shows the thermograms of the sample 23 obtained during the 70 millisecond pulse heating. Thermogram in Fig. 9a shows a recess at the end of the weld surface in the right side of sample.

Fig. 9b shows the thermogram after treatment in IrNDT program. Temperature distribution shows clearly the presence of defects in the weld:

- area "p1" is a place of higher temperature in comparison with surrounding areas. A thickness of the weld material in the area of "p1" have to be smaller because of the presence of a defect. Heat pulse heats the material at this point faster, hence the higher temperature is achieved (brighter gray level or light spot).
- area of "p2" is a place where the temperature is lower than the temperature at the point "p1". After the visual observation the surface of the sample of the weld, have a larger thickness than that of "p1", because in this point the material was slower heating.
- area "p3" is also a colder place on the weld (darker gray level), in which the temperature was lower than in the area "p1". It has been observed contour defect with circular form.
